**Building Assessment and Evaluation Study  
Of The  
Cranston Area Career & Technical Center  
For The  
Cranston School Department  
December 2011**

**Building Assessment & Evaluation Study**  
**Cranston Area Career Technical Center**  
**For The**  
**Cranston School Department**

## Building Assessment and Evaluation Study Cranston Area Career & Technical Center 100 Metropolitan Ave Cranston RI, 02920

FINAL REPORT: December 20, 2011

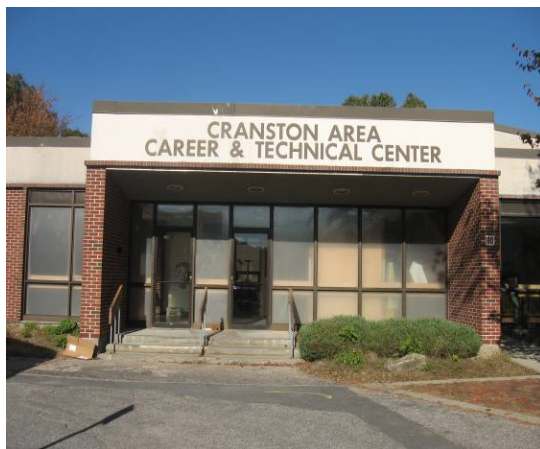
Main Entry

Nosings on concrete stairs are spalled and have come loose. The railings are rusted out at the base and need replacement. The railings do not meet current codes.

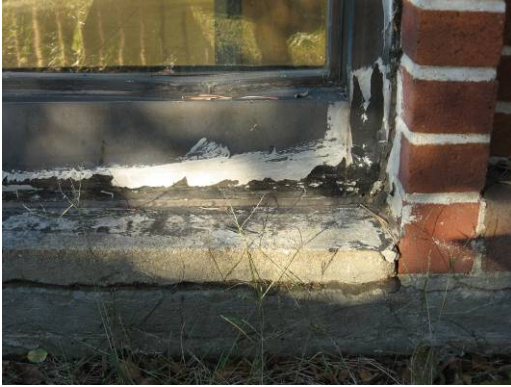
Corrosion of window frames due to water infiltration.

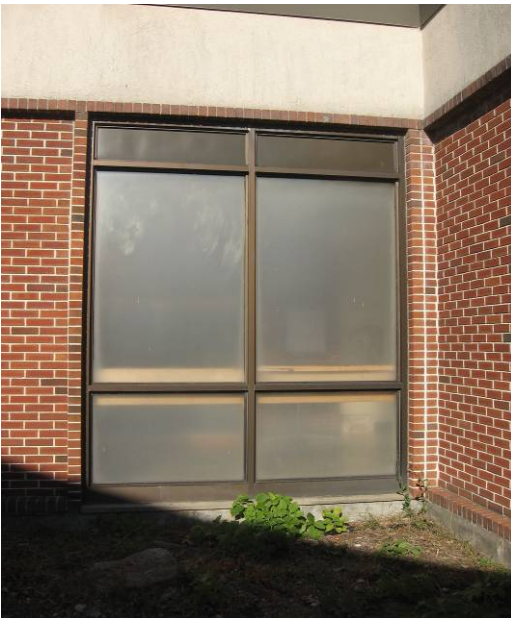
Fogged windows. Seals leaking.

The windows on the first floor of the building are full height units that sit on the foundation at floor level. The thermal glazing seals on most of the windows are past their life cycle and leaking resulting in fogged glass. The seal at the base of the windows at the foundation or floor is in poor condition and has failed in most cases resulting in water and moisture entering the building from the exterior. The windows on the upper level and ground level are in the same poor condition. It is recommended that all windows be replaced with new aluminum thermally broken insulated units.

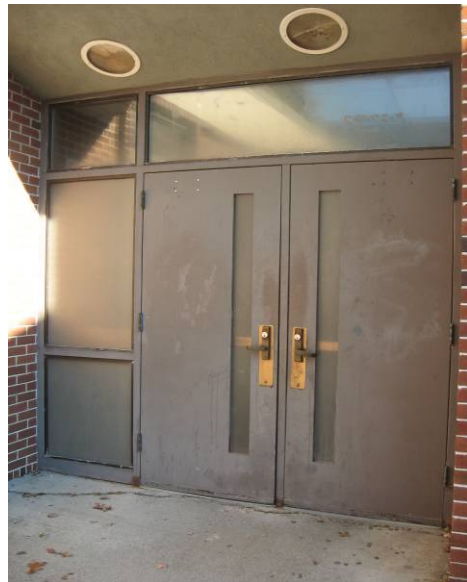
Exterior door system in poor condition and in need of replacement

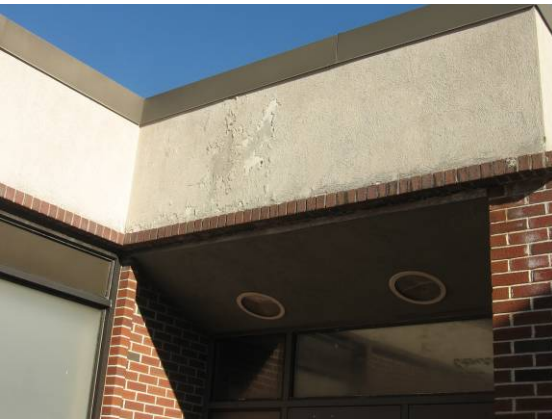
Damaged stucco fascia.

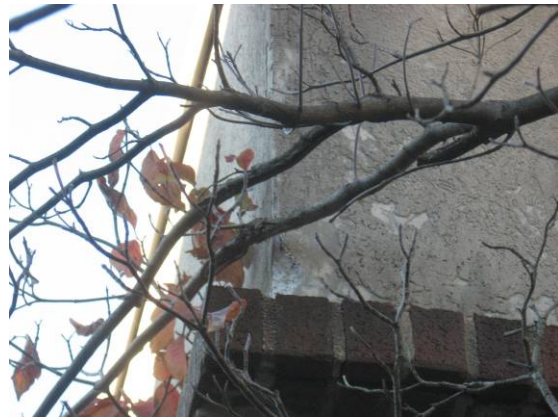
Damage caused by tree limbs.

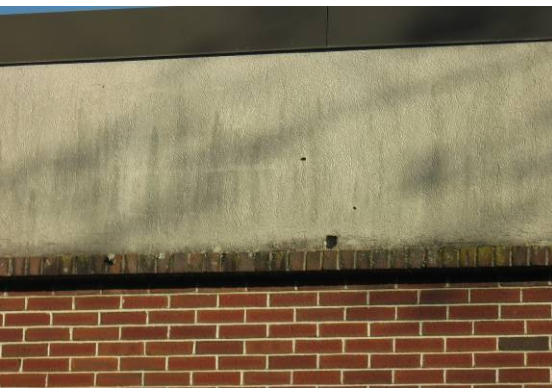
Dirt and mildew on stucco system.

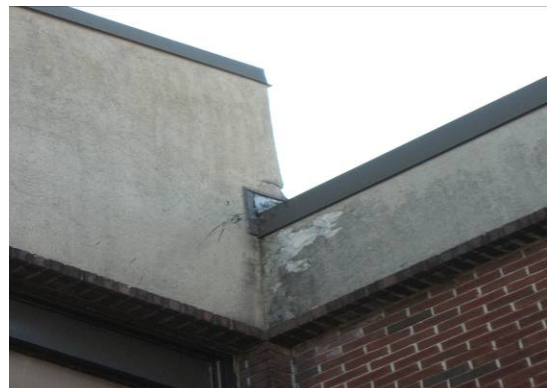
Damaged stucco fascia system.

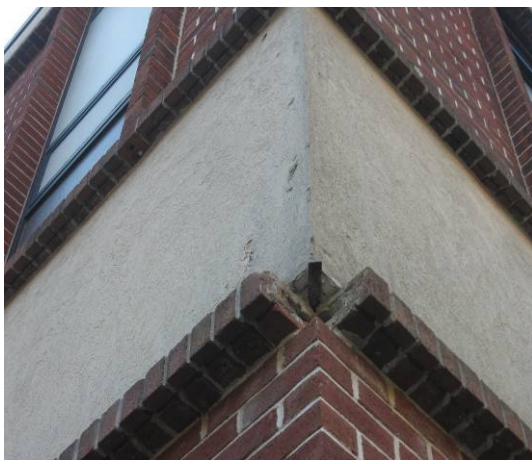
Damaged stucco system at corners.

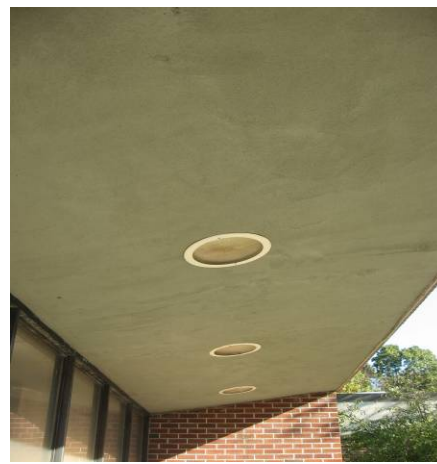
The ceiling at the main entry also has this stucco material on it and it also is in need of refinishing and caulking at the perimeter.

Ceiling at entrance in need of repair.

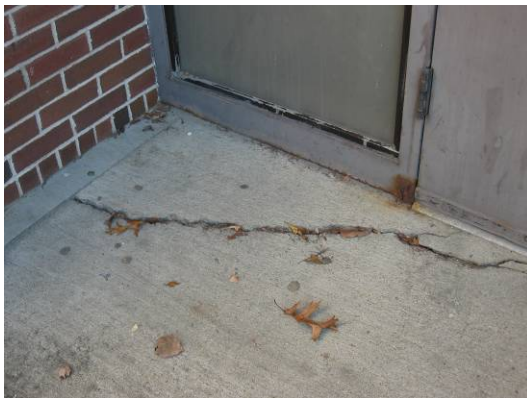
Cracked concrete walk.

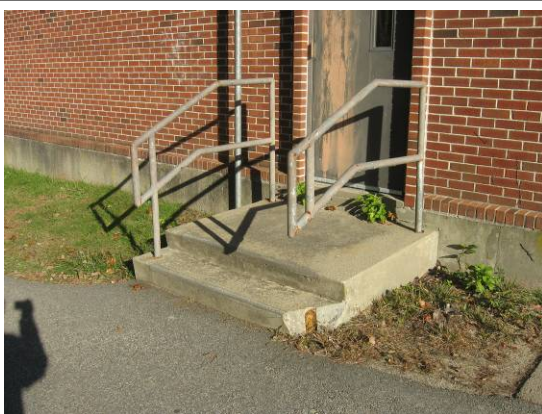
2. The concrete stair off the north side of the building at the Health V-21 space is in need of repair. The concrete stairs are in poor condition and have separated from the building. The railing is rusted out and broken and needs replacement. The current rails do not meet current codes.

Stair with broken corner and broken rail.

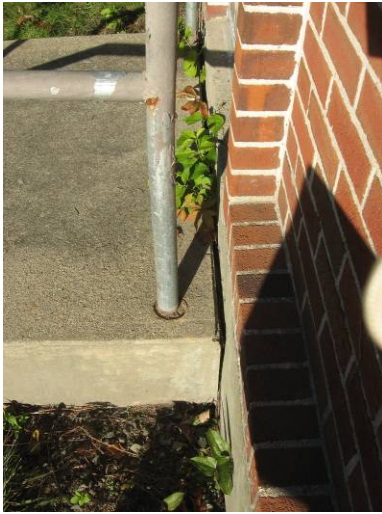
Landing separating from building

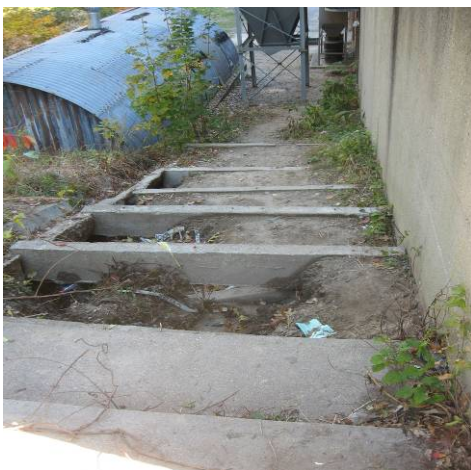
3. The old exterior stair at the rear of the building (NE corner) has been completely washed out and is a hazard at the present time. The stairwell used to be constructed of wood timber tread / riser nosings with gravel infill treads. The wood members have rotted away and the gravel treads have been washed out. There are no railings and there is no evidence that railings ever existed. All the gravel has washed out and down to the lower grade and has blocked one of the exit doors from the construction lab V-11. It is recommended that the entire stair be replaced and new code compliant railings be installed.

Washed out stairs.

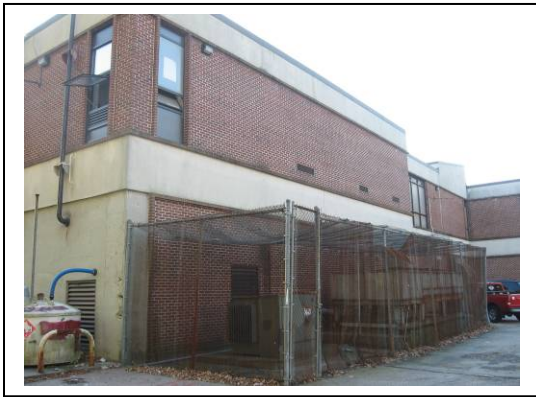
5. The fencing around the chiller and transformers on the east side of the building is in poor condition and needs to be replaced.

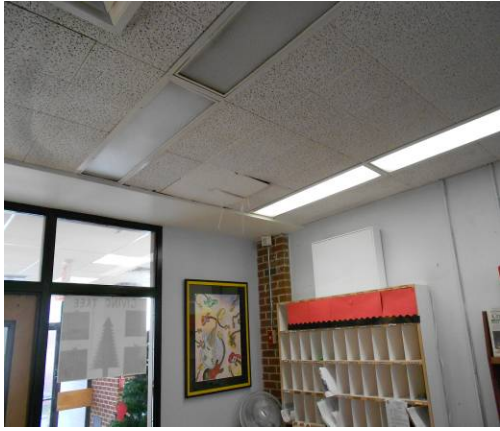
Ceiling tiles in poor condition and dirty.

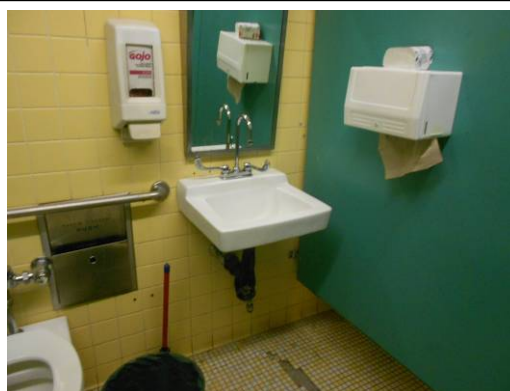
The HCP toilet stalls are not code compliant. Broken and missing floor tiles.

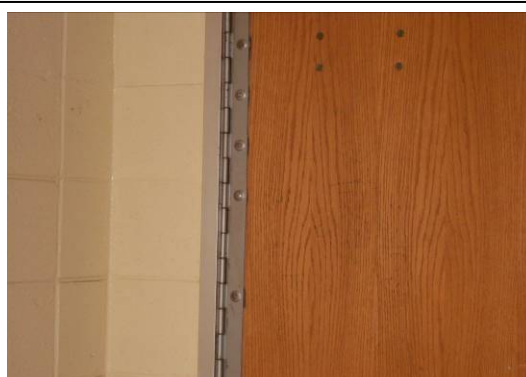
Roton hinge installed on face of door. This Is incorrect. There are also fasteners missing.

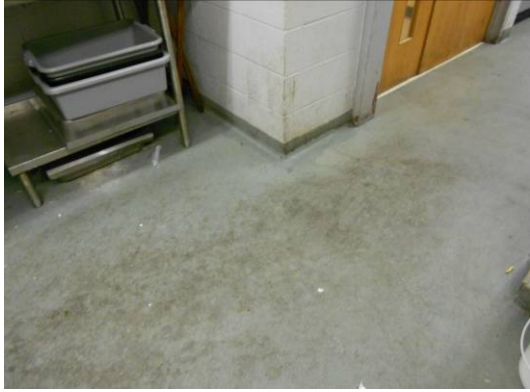
Kitchen flooring needs replacement.

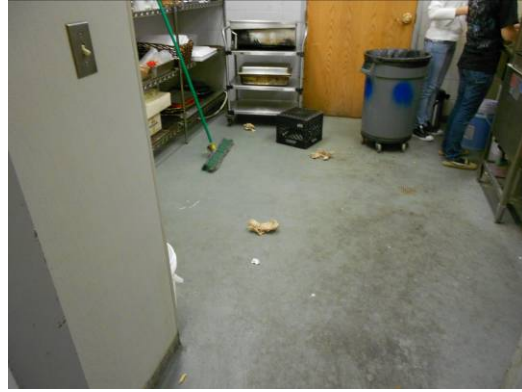
Kitchen flooring needs replacement.

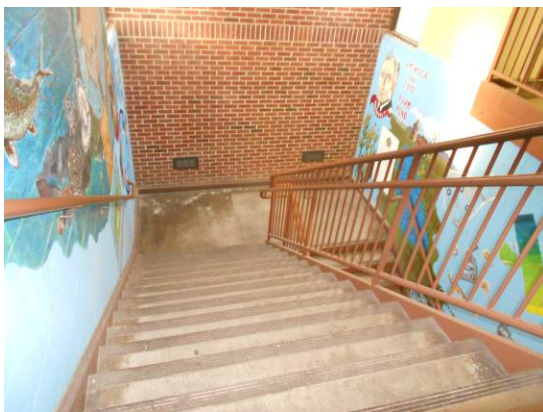
Treads and risers should have non-slip  
Rubber treads and risers installed.

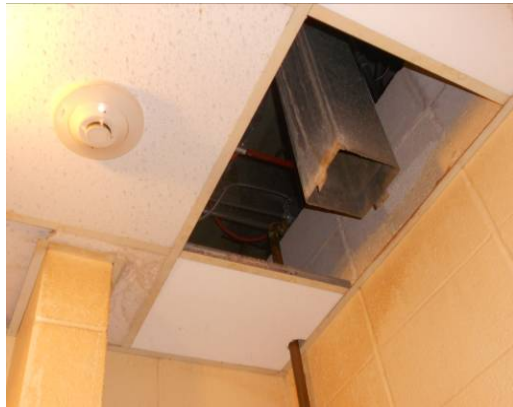
Open ductwork without a diffuser or grill.

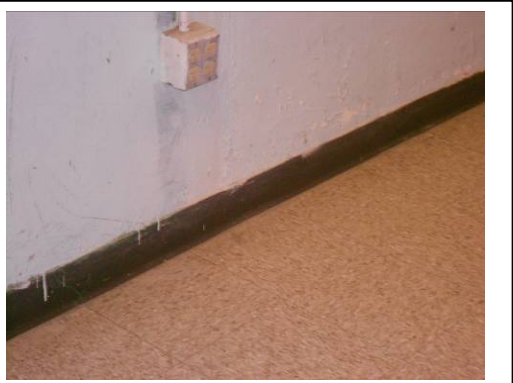
Water infiltration of lower level fdn wall.

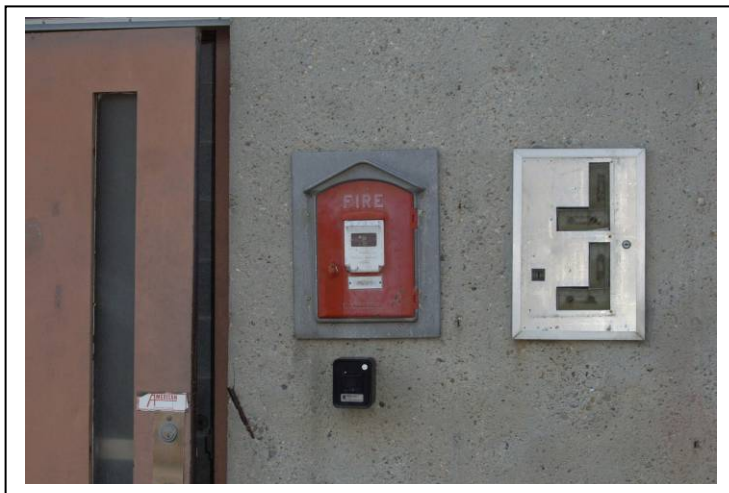
The Fire Alarm shunt trip type master box is located at an entrance into the Mechanical Room office on the east side of the building.

Up-grade the master box to a new local energy type master box.

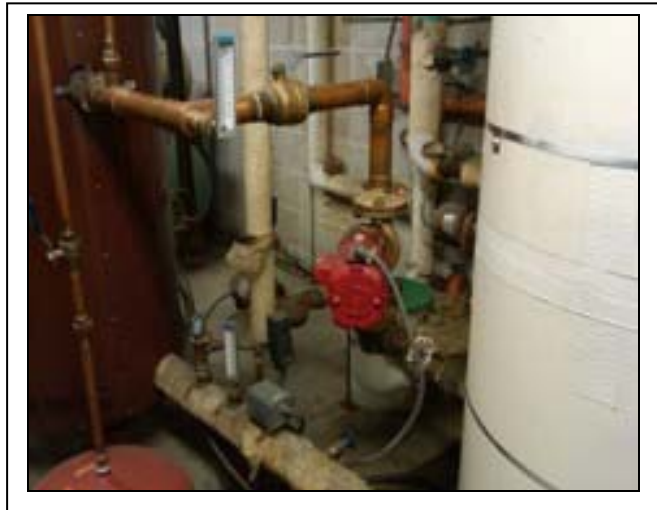
The majority of existing piping insulation throughout the boiler room either cracked or missing and should be replaced with new fiberglass wrapped insulation with a PVC jacket. Labels and flow arrows should also be installed.

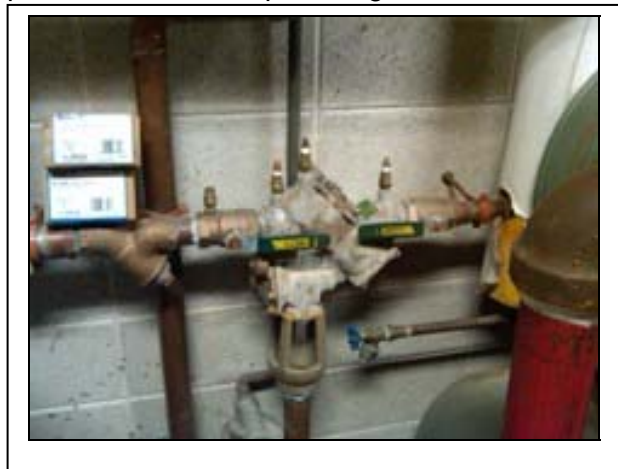
The existing boiler make-up water line must have a new reduced pressure zone backflow preventer. This is a plumbing code violation.

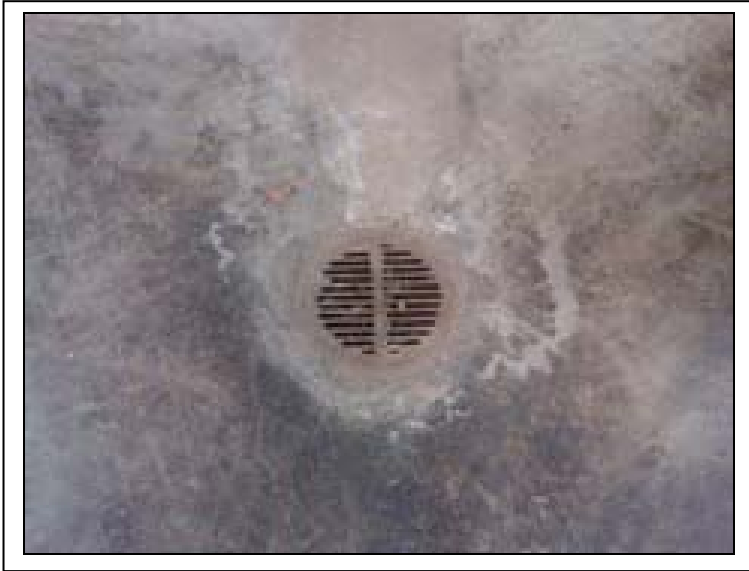
The majority of the existing floor drain strainers in the boiler room are blocked with debris and should be cleaned. Floor drain traps should be checked and filled with water to prevent sewer gas from coming up through the drain.

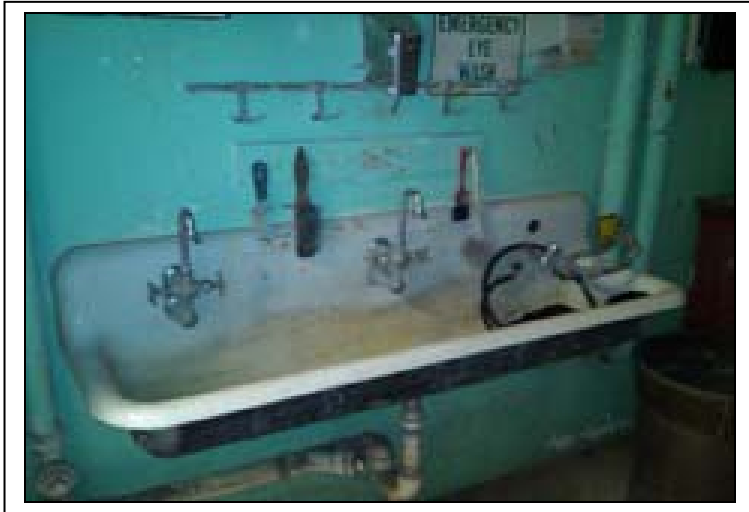
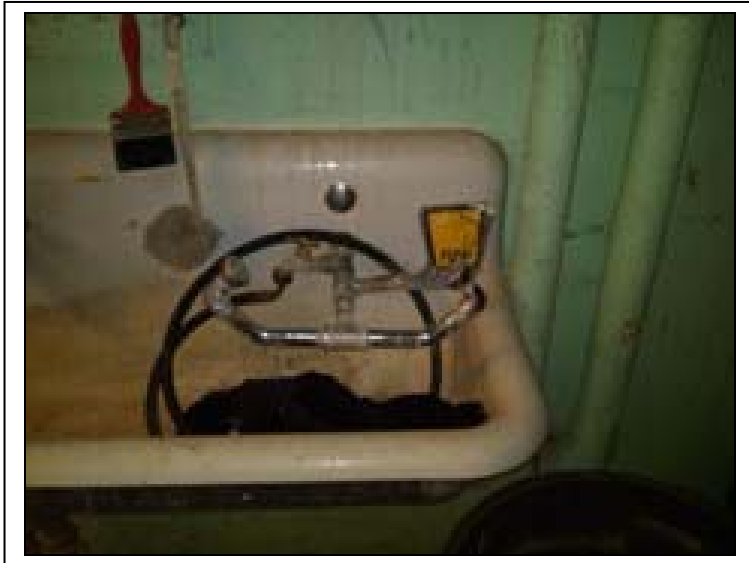
The emergency eyewash located within the wood shop must be provided with a new thermostatic mixing valve to supply tepid water (80 deg. F.) to the fixture. This is a ANSI code violation. A visible emergency eyewash sign must also be provided. Currently there is only a single emergency eyewash station and according to ANSI standards the distance of the eyewash to the furthest student must be within 10 seconds. An additional eyewash station should be provided in the furthest back corner of the wood working area.

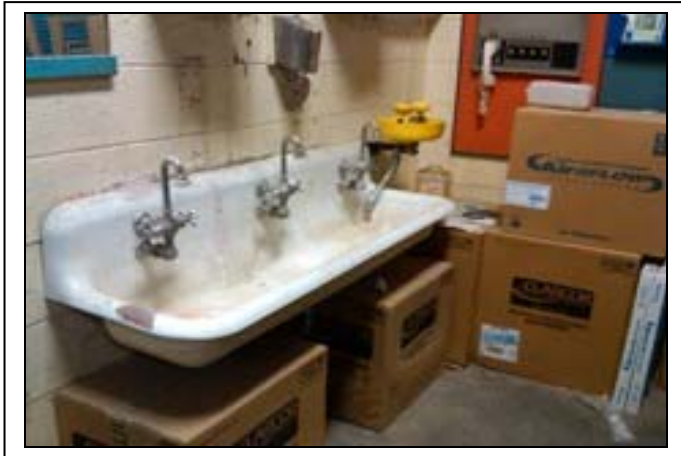
The emergency eyewash located within the wood shop must be provided with a new thermostatic mixing valve to supply tepid water (80 deg. F.) to the fixture. This is an ANSI code violation. A visible emergency eyewash sign must also be provided. Currently there is only a single emergency eyewash station and according to ANSI standards the distance of the eyewash to the furthest student must be within 10 seconds. An additional eyewash station should be provided in the furthest back corner of the Aquatic Studies area.

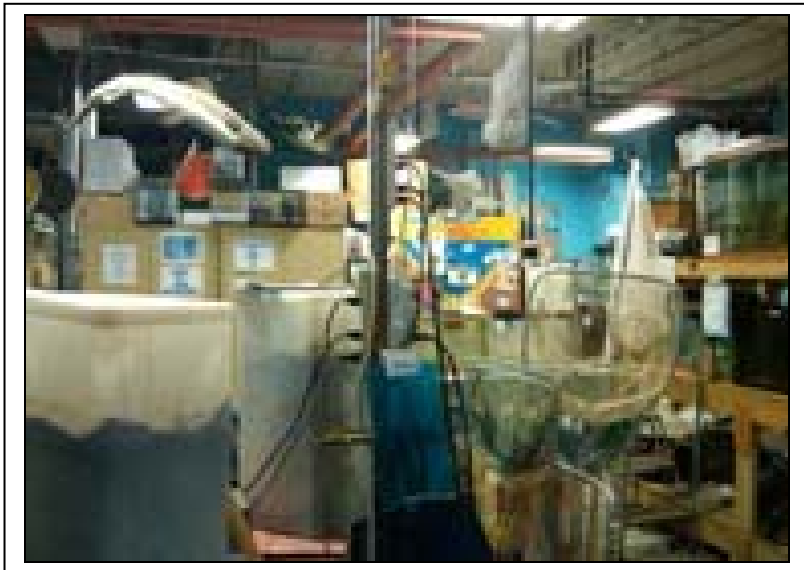
The domestic water supply line that provides water to the aquariums and various equipment does not have a backflow preventer. This is a code violation and a new Reduced Pressure Zone backflow preventer must be installed.

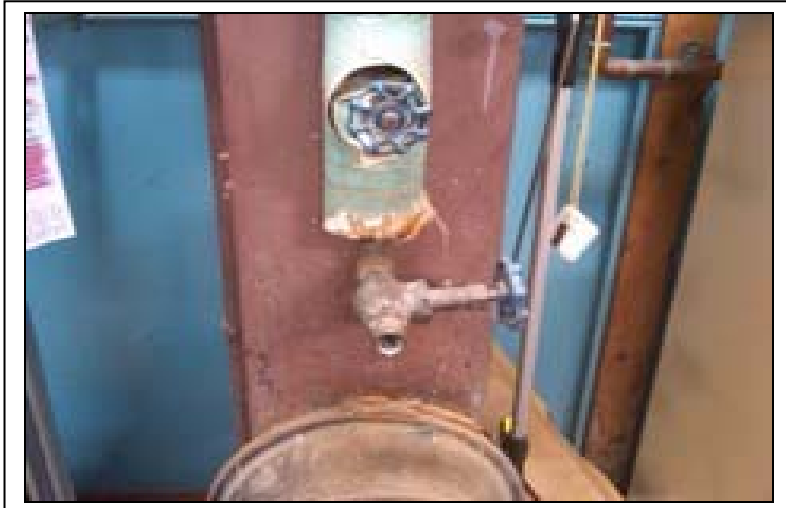
Hose bibs within the Aquatic Studies Area must be provided with code approved vacuum breakers. This is a plumbing code violation.

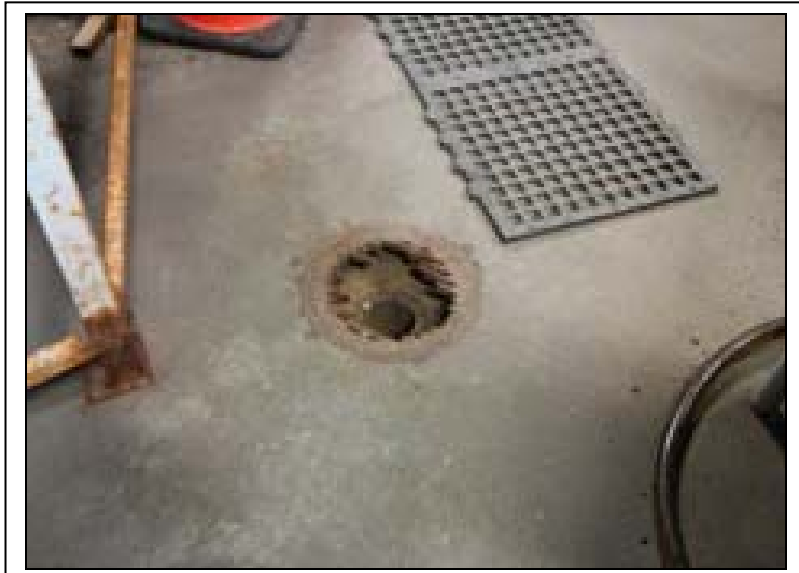
The floor drain located within the Aquatic Studies Area has a broken strainer and must be repaired. The floor drain trap should be checked and filled with water to prevent sewer gas from coming up through the drain.

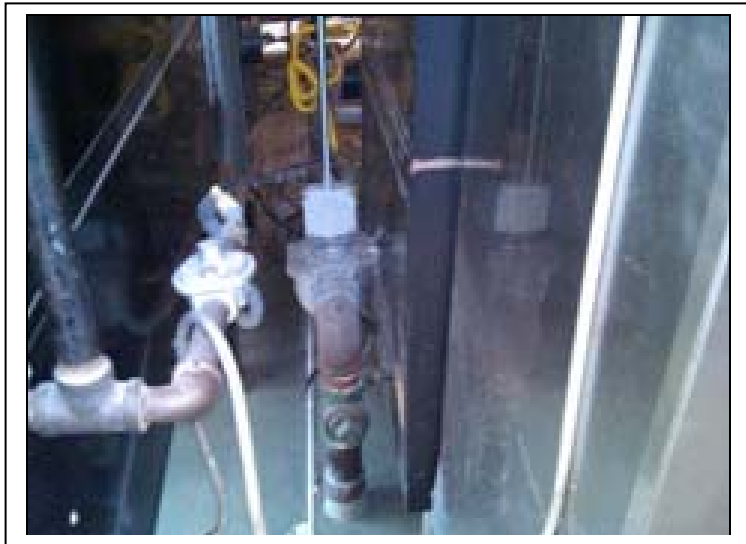
The natural gas piping system for the ranges and ovens comes up through the floor and serves each piece of equipment. There is no manual readily accessible emergency gas shut off valve. This is a violation of the Rhode Island Fuel Gas Code. A new readily accessible manual emergency shut off valve must be installed.

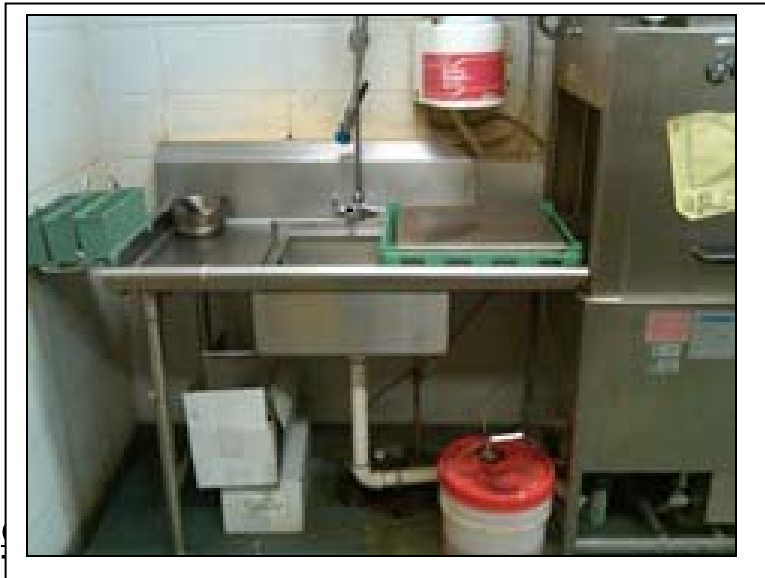
Currently there is no grease removal unit (GRU) for the pre-rinse sink. This is a Cranston sewer code violation. A new automatic grease removal unit must be installed for the pre-rinse sink.

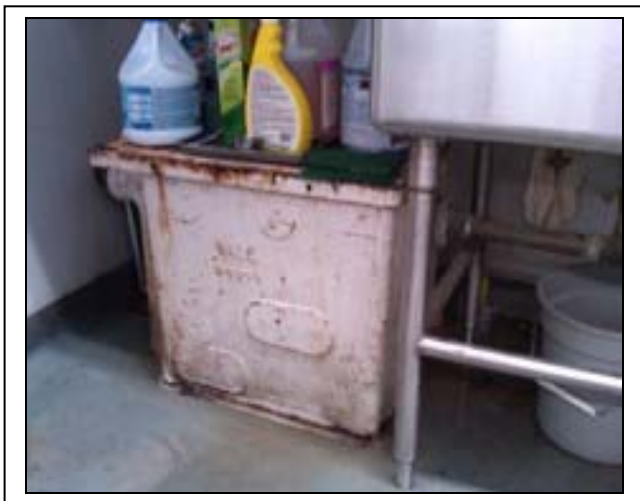
Currently there is an existing grease trap for the three pot sink. This grease trap is undersized and the type of grease trap is not code approved. This is a Cranston sewer code violation. A new automatic grease removal unit must be installed for the three pot sink.

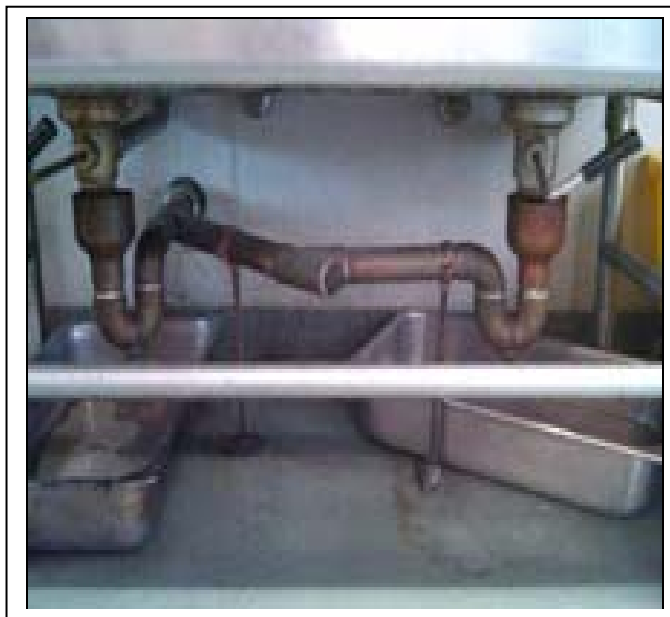
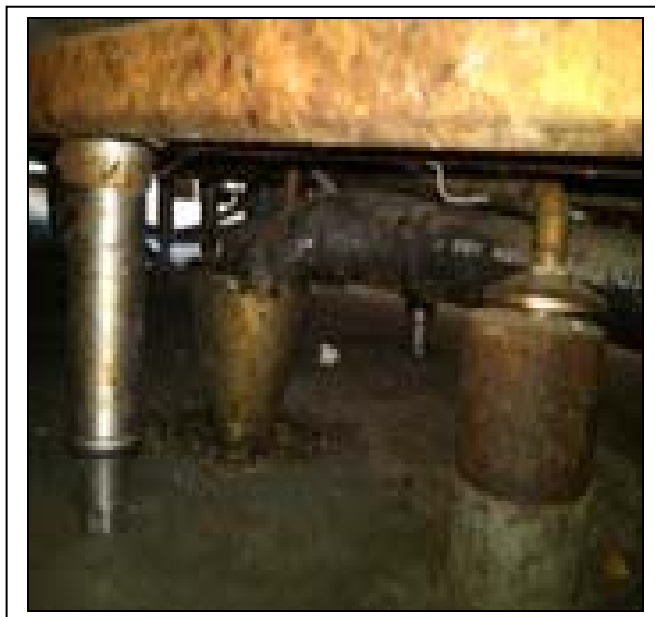
Currently all of the air gaps for the indirect waste pipes from the sinks and equipment are in violation of the International Plumbing Code. The air gaps must have a minimum 2" clearance from the top of any funnels or floor drain strainers.

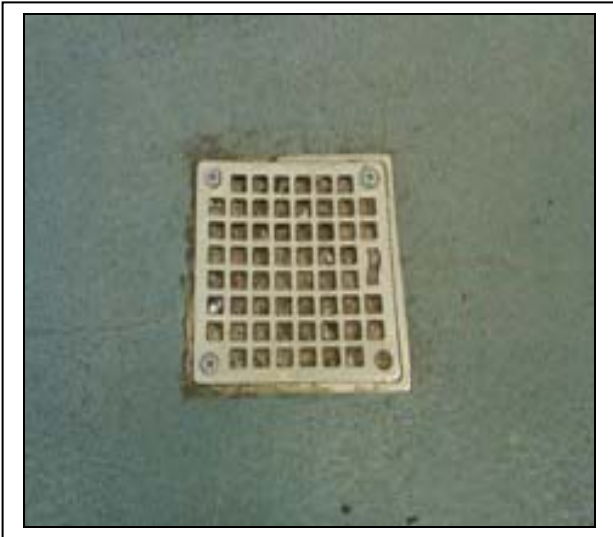
The majority of the existing floor drain strainers in the kitchen area are blocked with debris and must be cleaned. Floor drain traps must be checked and filled with water to prevent sewer gas from coming up through the drain. There are several floor drains that leak into the ceiling below and some have been disconnected. This is a health code violation.

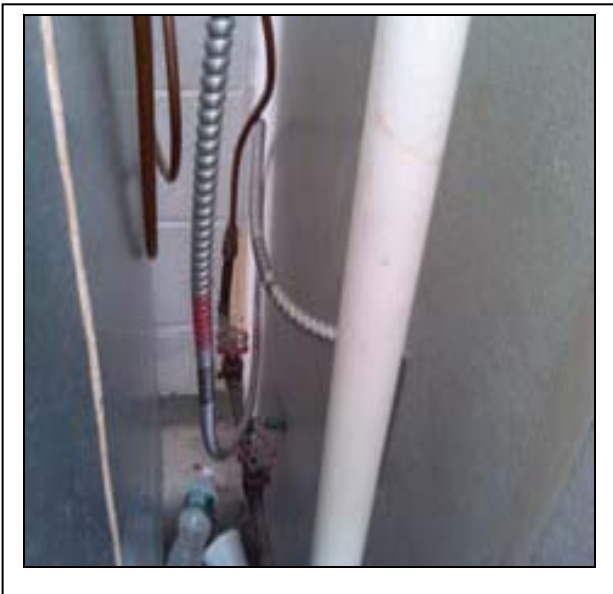
A backflow preventer must be installed for the existing ice maker. This is a health code violation.

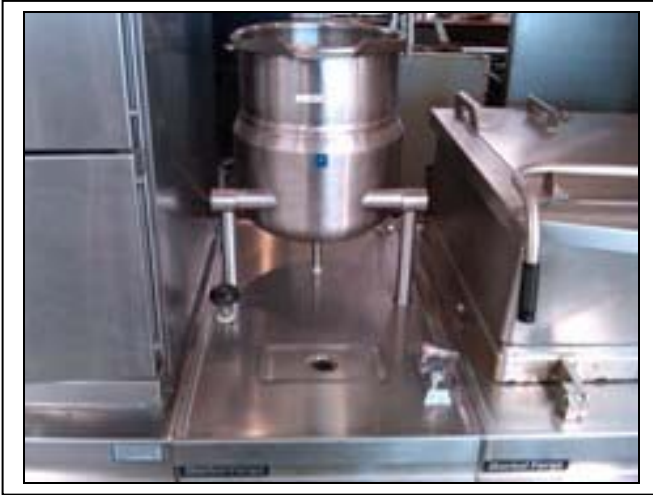
Currently there is not a grease removal unit for the soup kettle. The soup kettle drains directly into a floor drain. This is a Cranston sewer authority code violation. An automatic grease removal unit must be installed for the soup kettle.

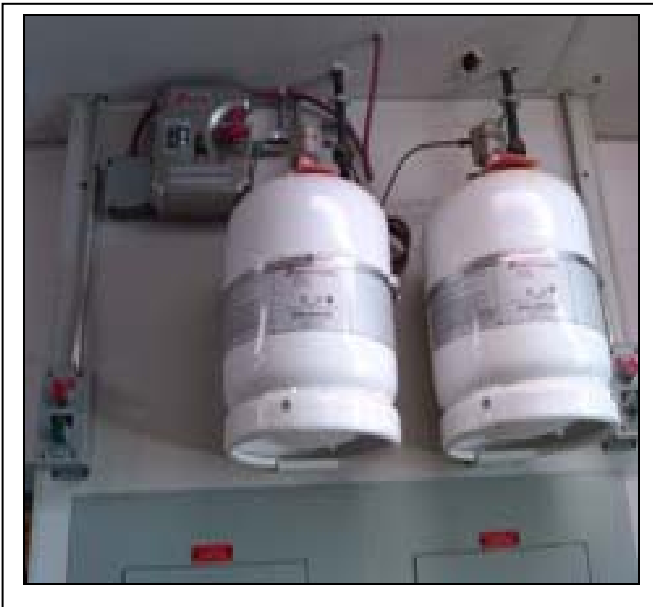
Emergency pull stations are required to be located at each exist door. Currently there is an emergency pull station but it is not located near the main exit door. This is a Rhode Island Fire Code violation.

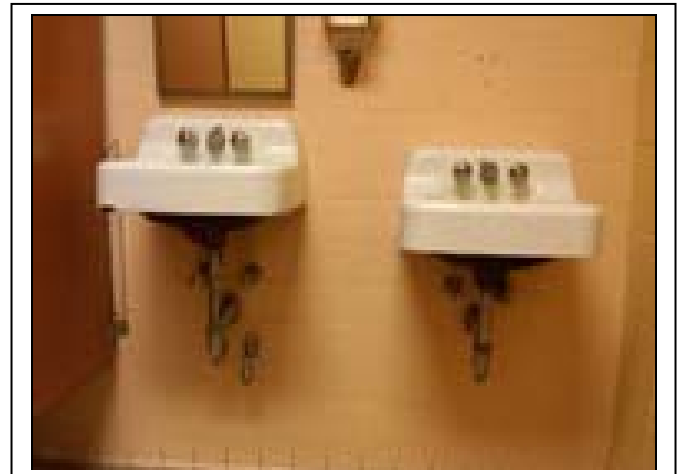
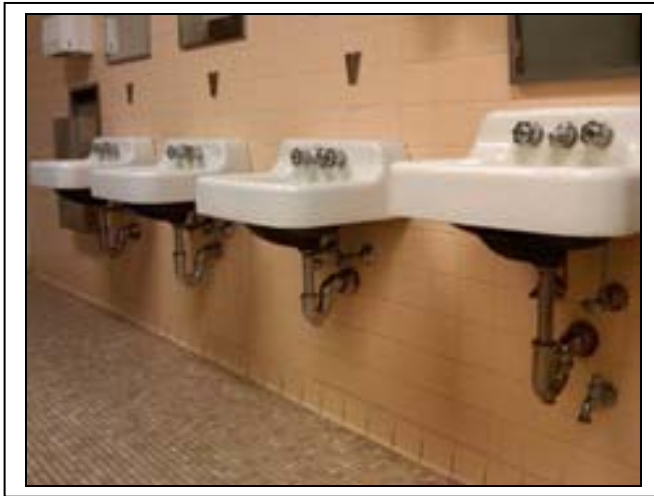
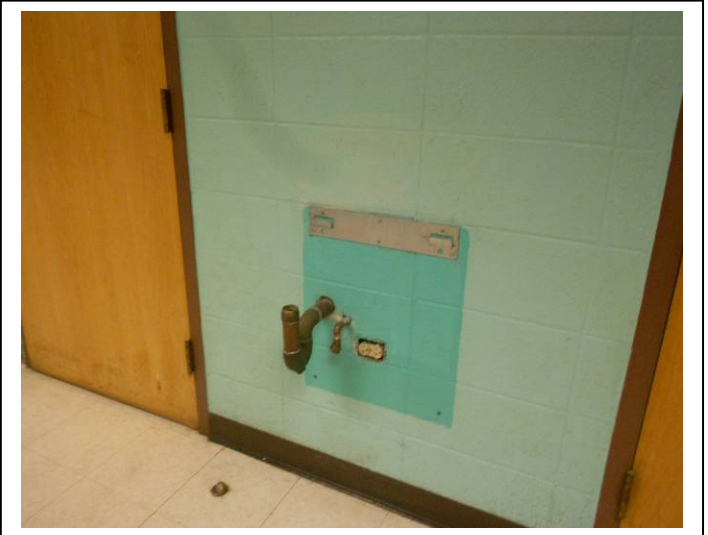
The building has been provided with existing toilet room non-compliant ADA fixtures, particularly the lavatories. The lavatories must have ADA compliant faucets as well as an ADA compliant insulation kit for the exposed piping below the lavatories. The lavatories do not have these features and are

therefore in violation of the ADA Accessible Code. There are also missing fixtures such as an ADA compliant dual level electric water cooler for each floor. This is an ANSI code violation.
